INDOOR AIR QUALITY ASSESSMENT

**Memorial Middle School
81 Central Ave
Hull, MA 02045**

Prepared by:
Massachusetts Department of Public Health
Center for Environmental Health
Emergency Response Indoor Air Quality Program
April 2007

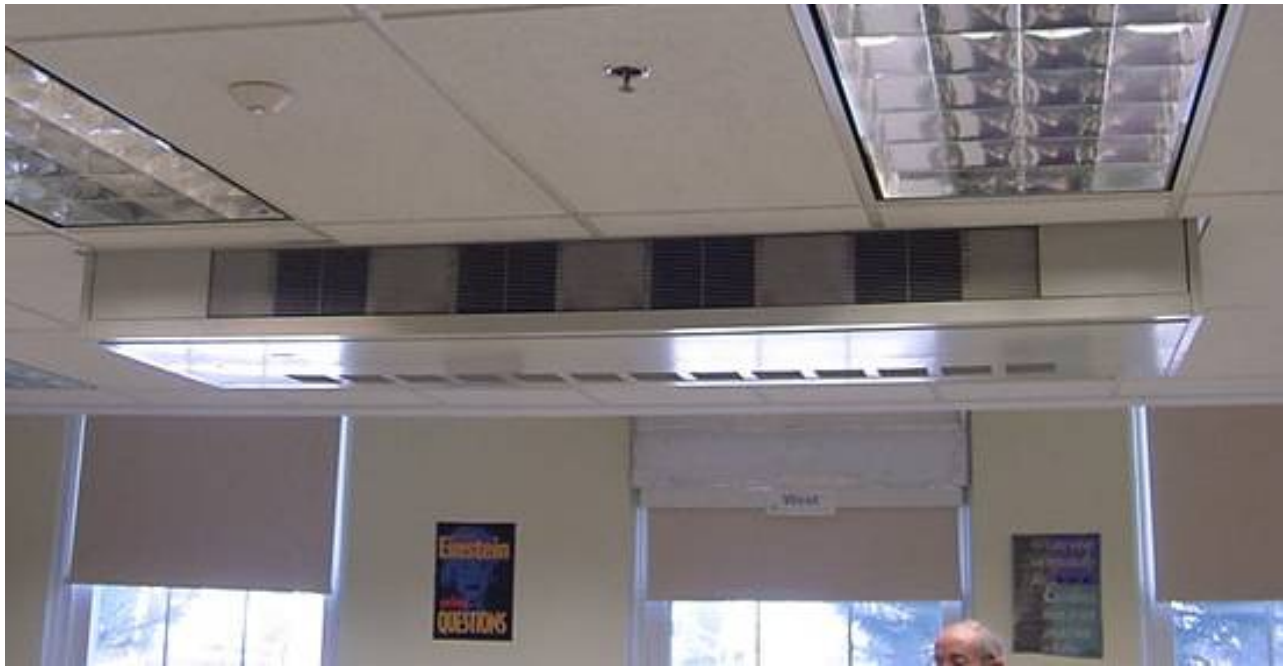
Picture 1

Fresh air in exterior classrooms is supplied by unit ventilator (univent) systems (Pictures 1 and 2). A univent is designed to draw air from outdoors through a fresh air intake located on the exterior wall of the building (Picture 3). Return air is drawn through an air intake located at the base of the unit ([Figure 1](#)). Fresh and return air are mixed, filtered, heated and provided to classrooms through an air diffuser located in the top of the unit. Several univents were deactivated during the assessment (Table 1), therefore no mechanical means to introduce fresh air was being provided in these areas. The univent in room 327 was reportedly deactivated due to excessive noise and heat. Obstructions to airflow, such as papers and books stored on univents and bookcases, carts and desks in front of univent returns, were seen in several classrooms. In order for univents to provide fresh air as designed, units must be activated and remain free of obstructions.

Ceiling-Mounted Univert First Floor

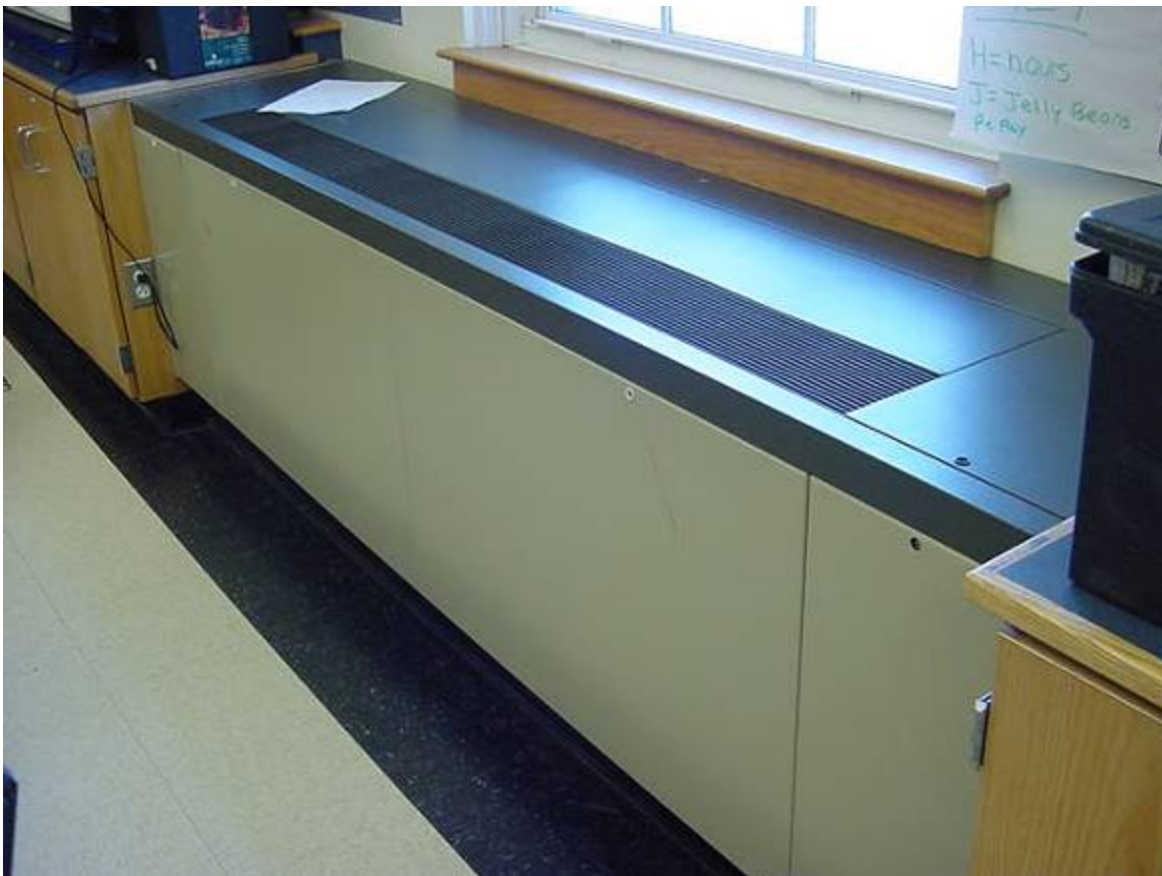
Picture 2

Typical Wall-Mounted Univert

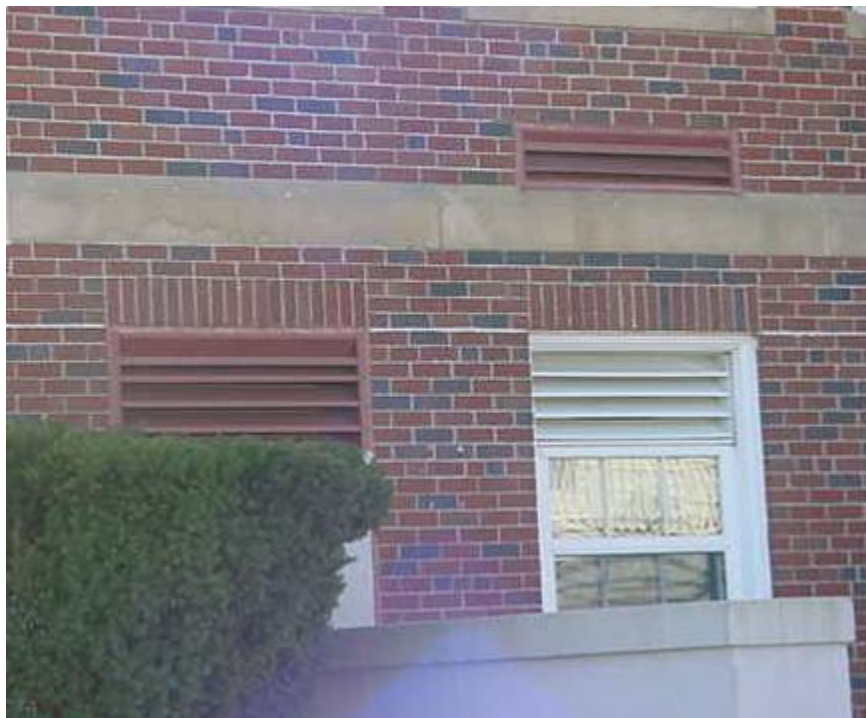
Picture 3

Univent Fresh Air Intakes

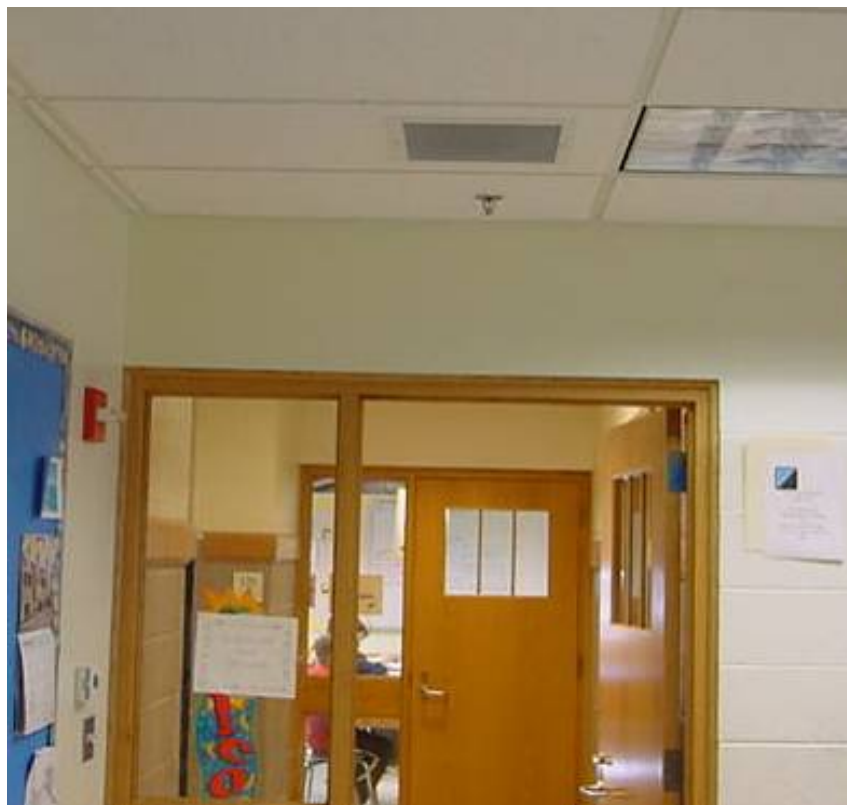
Picture 4

Exhaust ventilation in classrooms is provided by ceiling-mounted vents (Picture 4) powered by rooftop motors (Picture 5). Exhaust vents were either not drawing or were drawing weakly in several areas (Table 1). CEH staff examined the vent in classroom 140; no draw was detected and it could not be determined if the vent was ducted to a rooftop motor (Picture 6). In order to function properly, exhaust vents must be activated during periods of occupancy. Without sufficient supply and exhaust ventilation, environmental pollutants can build up and lead to indoor air quality/comfort complaints. It is important to note that the location of some exhaust vents can limit exhaust efficiency. In some classrooms, exhaust vents are located above hallway doors (Picture 4). When classroom doors are open, exhaust vents tend to draw air from the hallway, thereby reducing the effectiveness of the vents to remove common environmental pollutants from classrooms.

Classroom Exhaust Vent, Note Proximity to Hallway Door

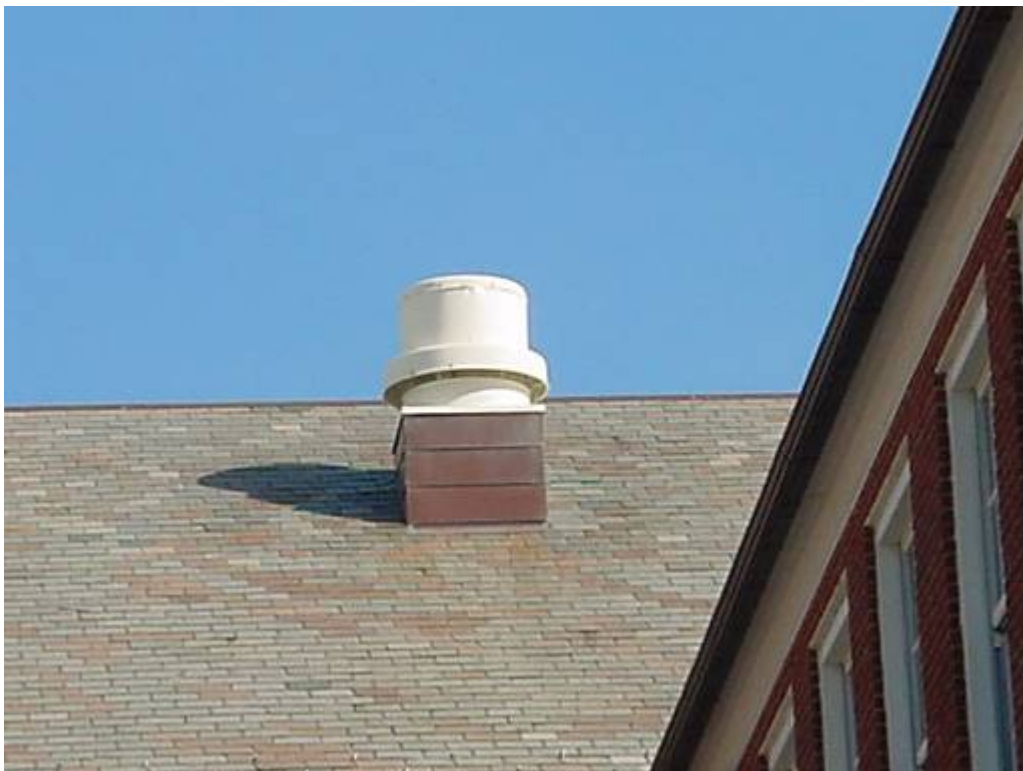
Picture 5

Rooftop Exhaust Motor

4. Remove all blockages from univents to ensure adequate airflow.
5. Inspect exhaust motors and belts for proper function, repair and replace as necessary.

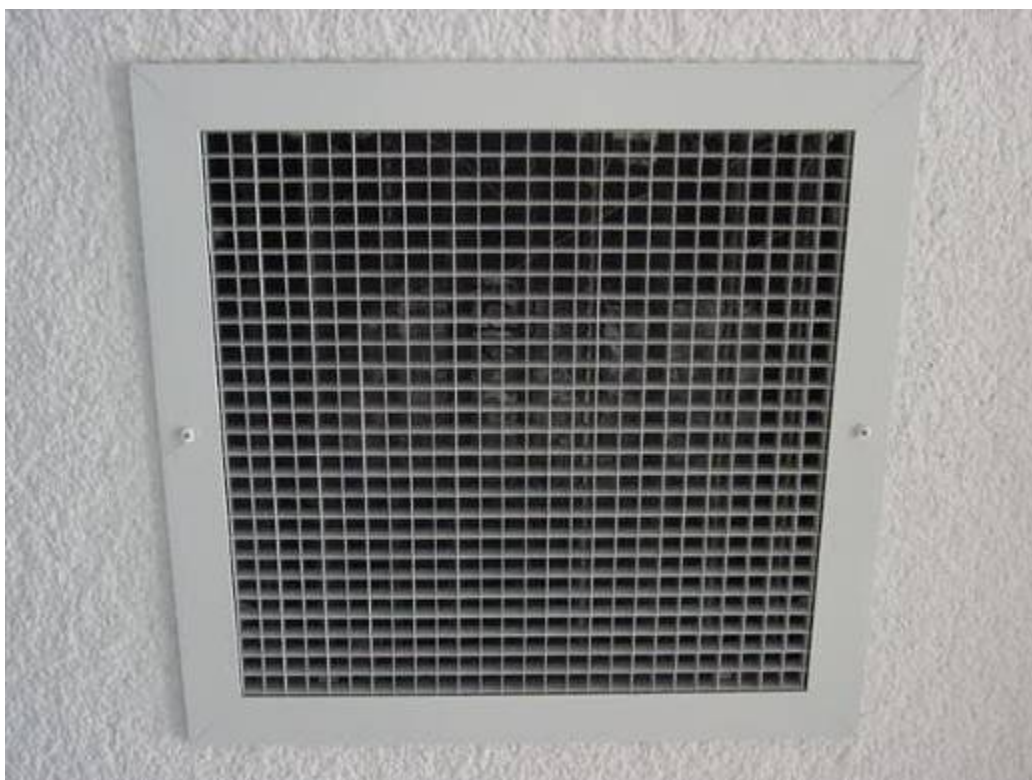
Picture 6

Ceiling-Mounted Exhaust Vent in Classroom 140

6. Examine ceiling-mounted exhaust vent in classroom 140 (and similar vents), to determine if they are ducted to rooftop motors. If not, consider attaching to provide mechanical exhaust ventilation.

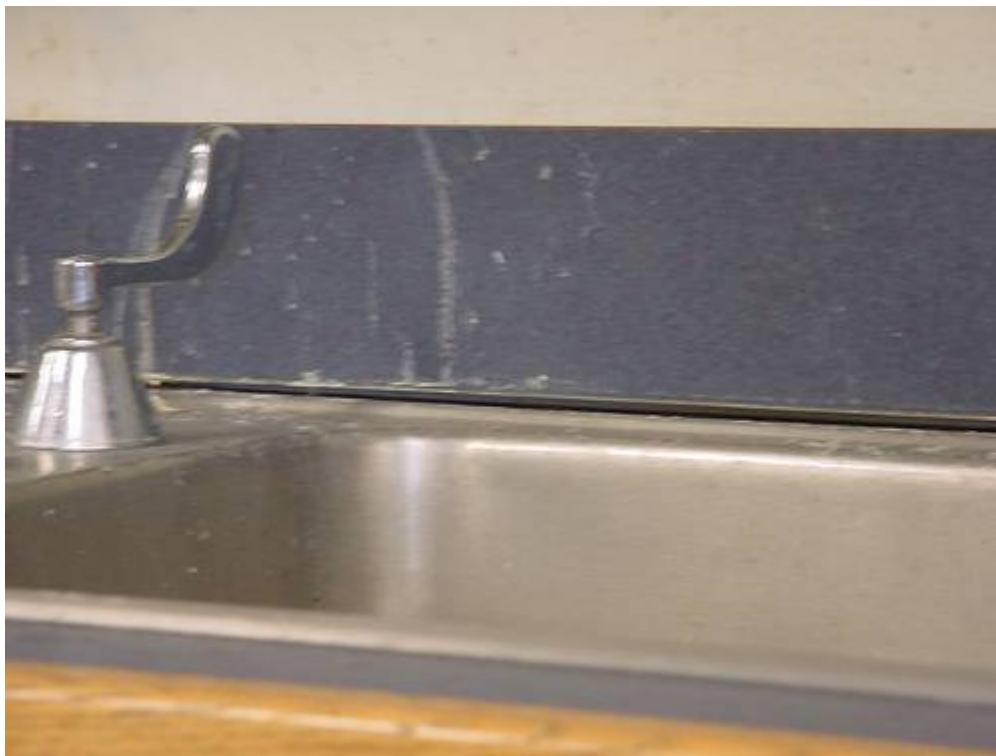
Picture 7

Water stained ceiling tiles were observed in classroom 329, which can indicate leaks from the roof or plumbing system. Water-damaged ceiling tiles can provide a source for mold and should be replaced after a water leak is discovered and repaired. Breaches between the sink countertop and backsplash were seen in a few areas (Picture 7/Table 1). Improper drainage or

sink overflow can lead to water penetration to countertop wood, the cabinet interior and areas behind cabinets. Like other porous materials, if these materials become wet repeatedly they can provide a medium for mold growth.

Breach between Sink Countertop and Backsplash

11. Seal areas between sink countertops and backsplashes to prevent water-damage to the interior of cabinets and adjacent wallboard.
12. Ensure cardboard material shown in Picture 10 is removed from univent fresh air intake.

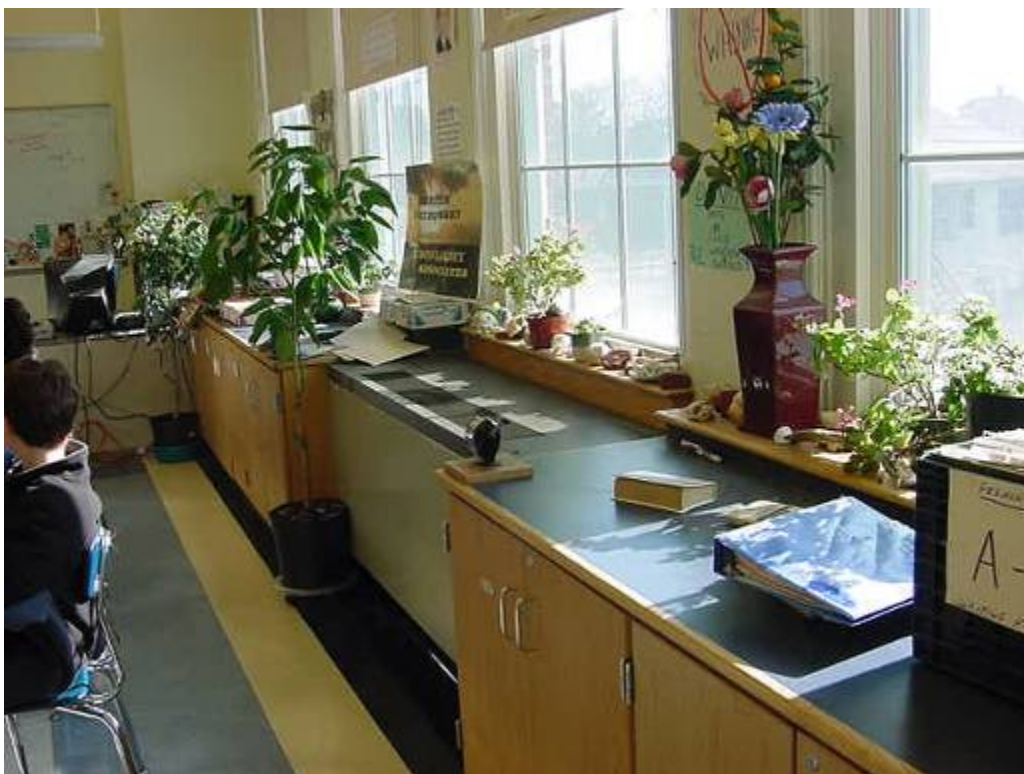
Picture 8

Plants were noted in several classrooms (Picture 8). Plants can be a source of pollen and mold, which can be respiratory irritants for some individuals. Plants should be properly maintained and equipped with drip pans to prevent water damage to porous building materials (Picture 9), which can lead to mold growth. Plants should also be located away from ventilation sources (e.g., air intakes, univent diffusers) to prevent the entrainment and/or aerosolization of dirt, pollen or mold.

Plants in Classroom

10. Ensure plants have drip pans. Examine drip pans periodically for mold growth and disinfect with an appropriate antimicrobial where necessary. Keep plants away from the air stream of univents.

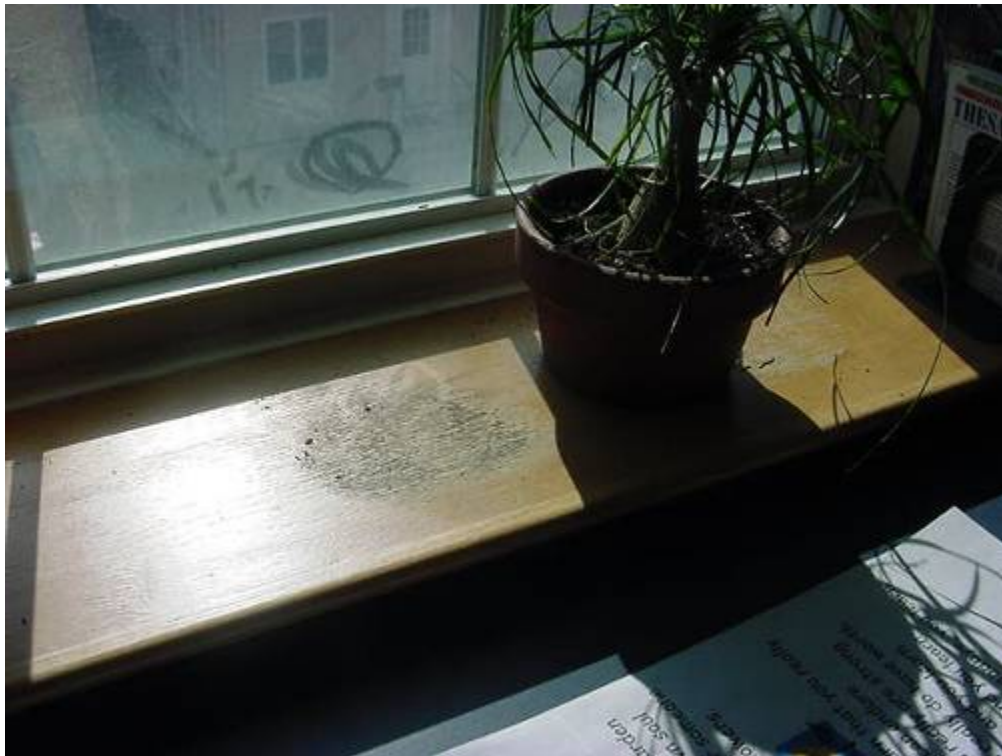
Picture 9

Plant Moved to Show Water Damaged Wooden Windowsill

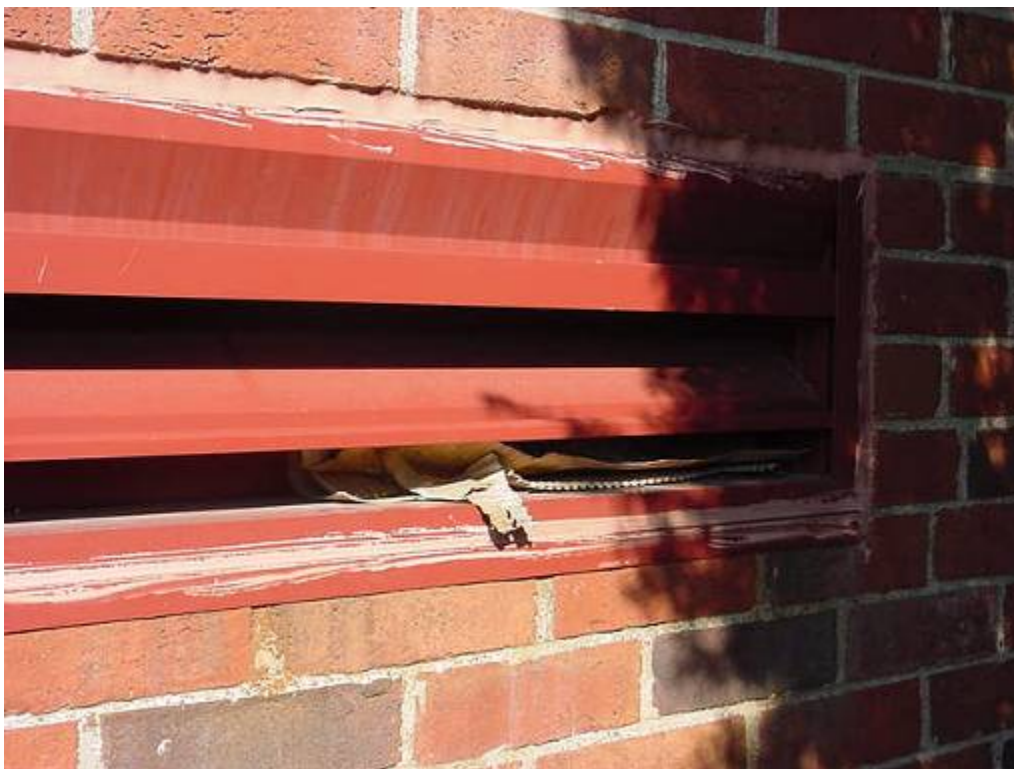
Picture 10

During an exterior inspection of the building CEH staff observed cardboard material protruding from a ground level univent fresh air intake (Picture 10). If wetted repeatedly, porous materials can become colonized with mold and provide a source of spores and odors. Upon discovery, CEH staff reported this finding and recommended to Mr. Twombly and Principal Stephens that the material be removed.

Cardboard Protruding from Univent Fresh Air Intake

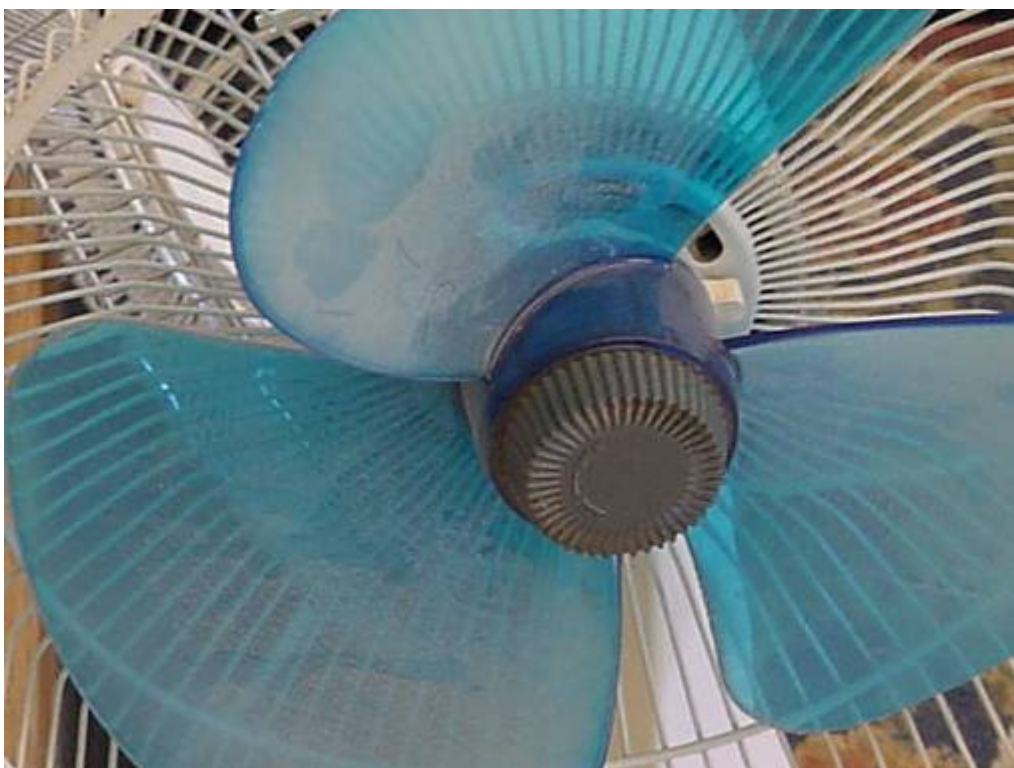
Picture 12

A number of exhaust/return vents and personal fans had accumulated dust (Picture 12). If exhaust vents are not functioning, backdrafting can occur, which can re-aerosolize dust particles. In addition, these materials can accumulate on flat surfaces (e.g., desktops, shelving and carpets) in occupied areas and subsequently be re-aerosolized causing further irritation. Dust can be irritating to eyes, nose and the respiratory tract.

Dust Accumulation on Fan Blades

14. Clean accumulated dust and debris from the interior of univent air diffusers, exhaust vents and blades of personal fans.
15. Store cleaning products properly and out of reach of students.
